Manhole Inspection Summary

Manhole # S57A__014MH

Location Address: **201 n kresson st**

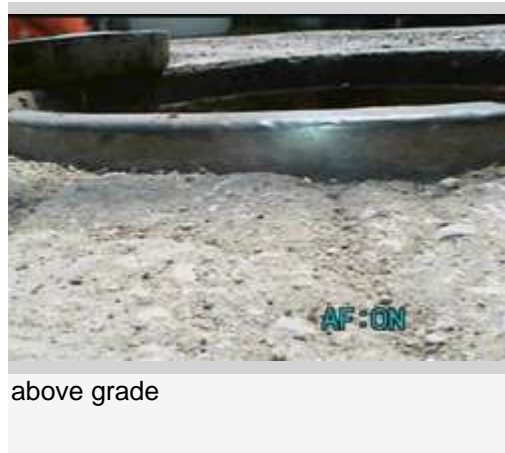
misc above grade

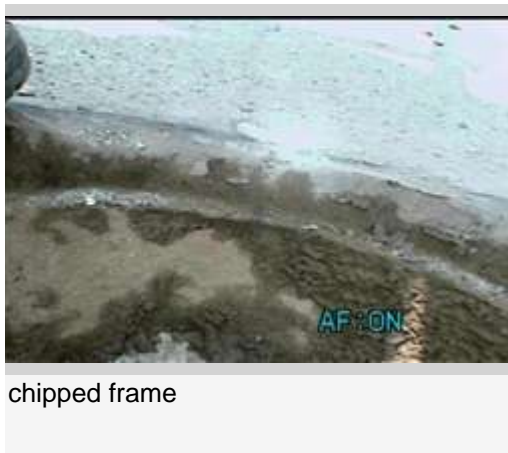
misc frame

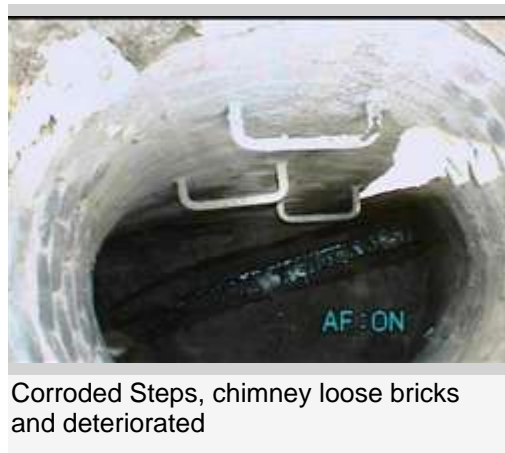
Defect 3

chipped frame

Corroded Steps, chimney loose bricks and deteriorated

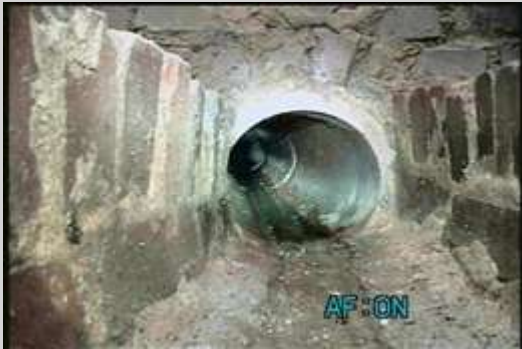
12 O'Clock Outflow

8 in. Circular Gravity Sewer
Pipe Out @ 12 O'Clock

Invert Depth: **7.75** (ft.) Flow Characteristics: **Slow**

Infiltration: **None** Pipe Seal Cond: **Unknown**

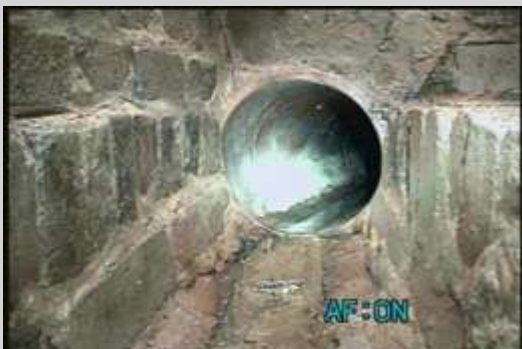
6 O'Clock Inflow

8 in. Circular Gravity Sewer
Pipe In @ 6 O'Clock

Invert Depth: **6.96** (ft.) Flow Characteristics: **Slow**

Infiltration: **None** Pipe Seal Cond: **Unknown**
